# Ecological Resource Consultants, Inc.

**RE: Tree Inventory – North Boulder Armory, 4750 Broadway Street, Boulder, Colorado 80304**

## APPENDIX A – PHOTOGRAPHS

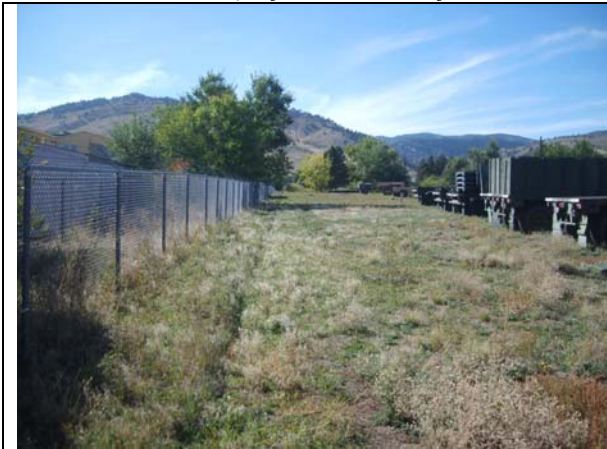
*Photo 1. Looking west down the south property boundary from the SE corner of the property.*

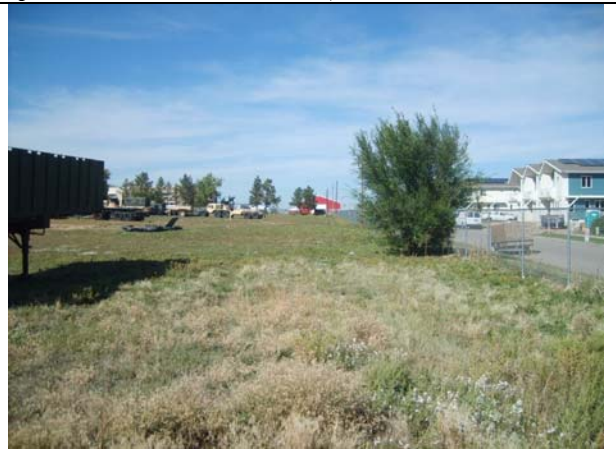
*Photo 2. Looking north down the east property boundary from the SE corner of the property.*

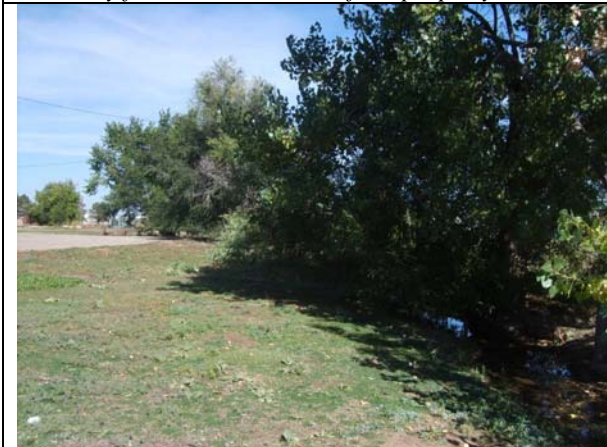
*Photo 3. Looking NE down the Silver Lake Irrigation Ditch from near the SW corner of the property.*

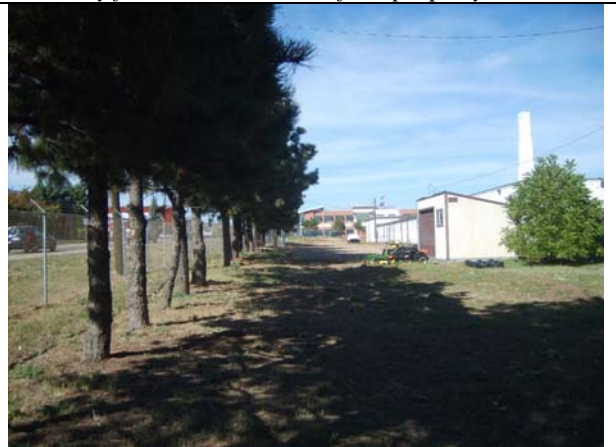
*Photo 4. Looking north down the west property boundary from near the SW corner of the property.*

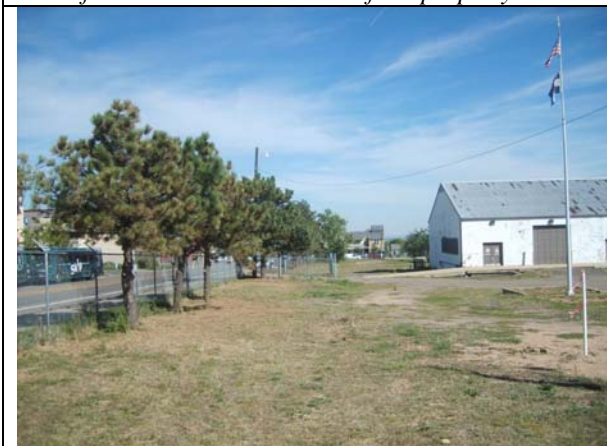
*Photo 5. Looking east down the north property boundary from near the NW corner of the property.*

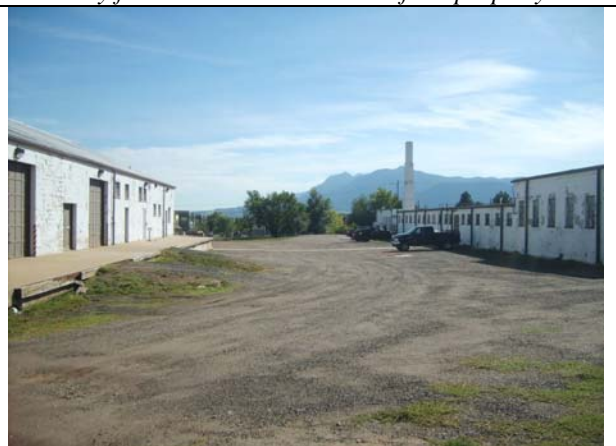
*Photo 6. Looking south at the interior portion of the property from the northern property boundary.*

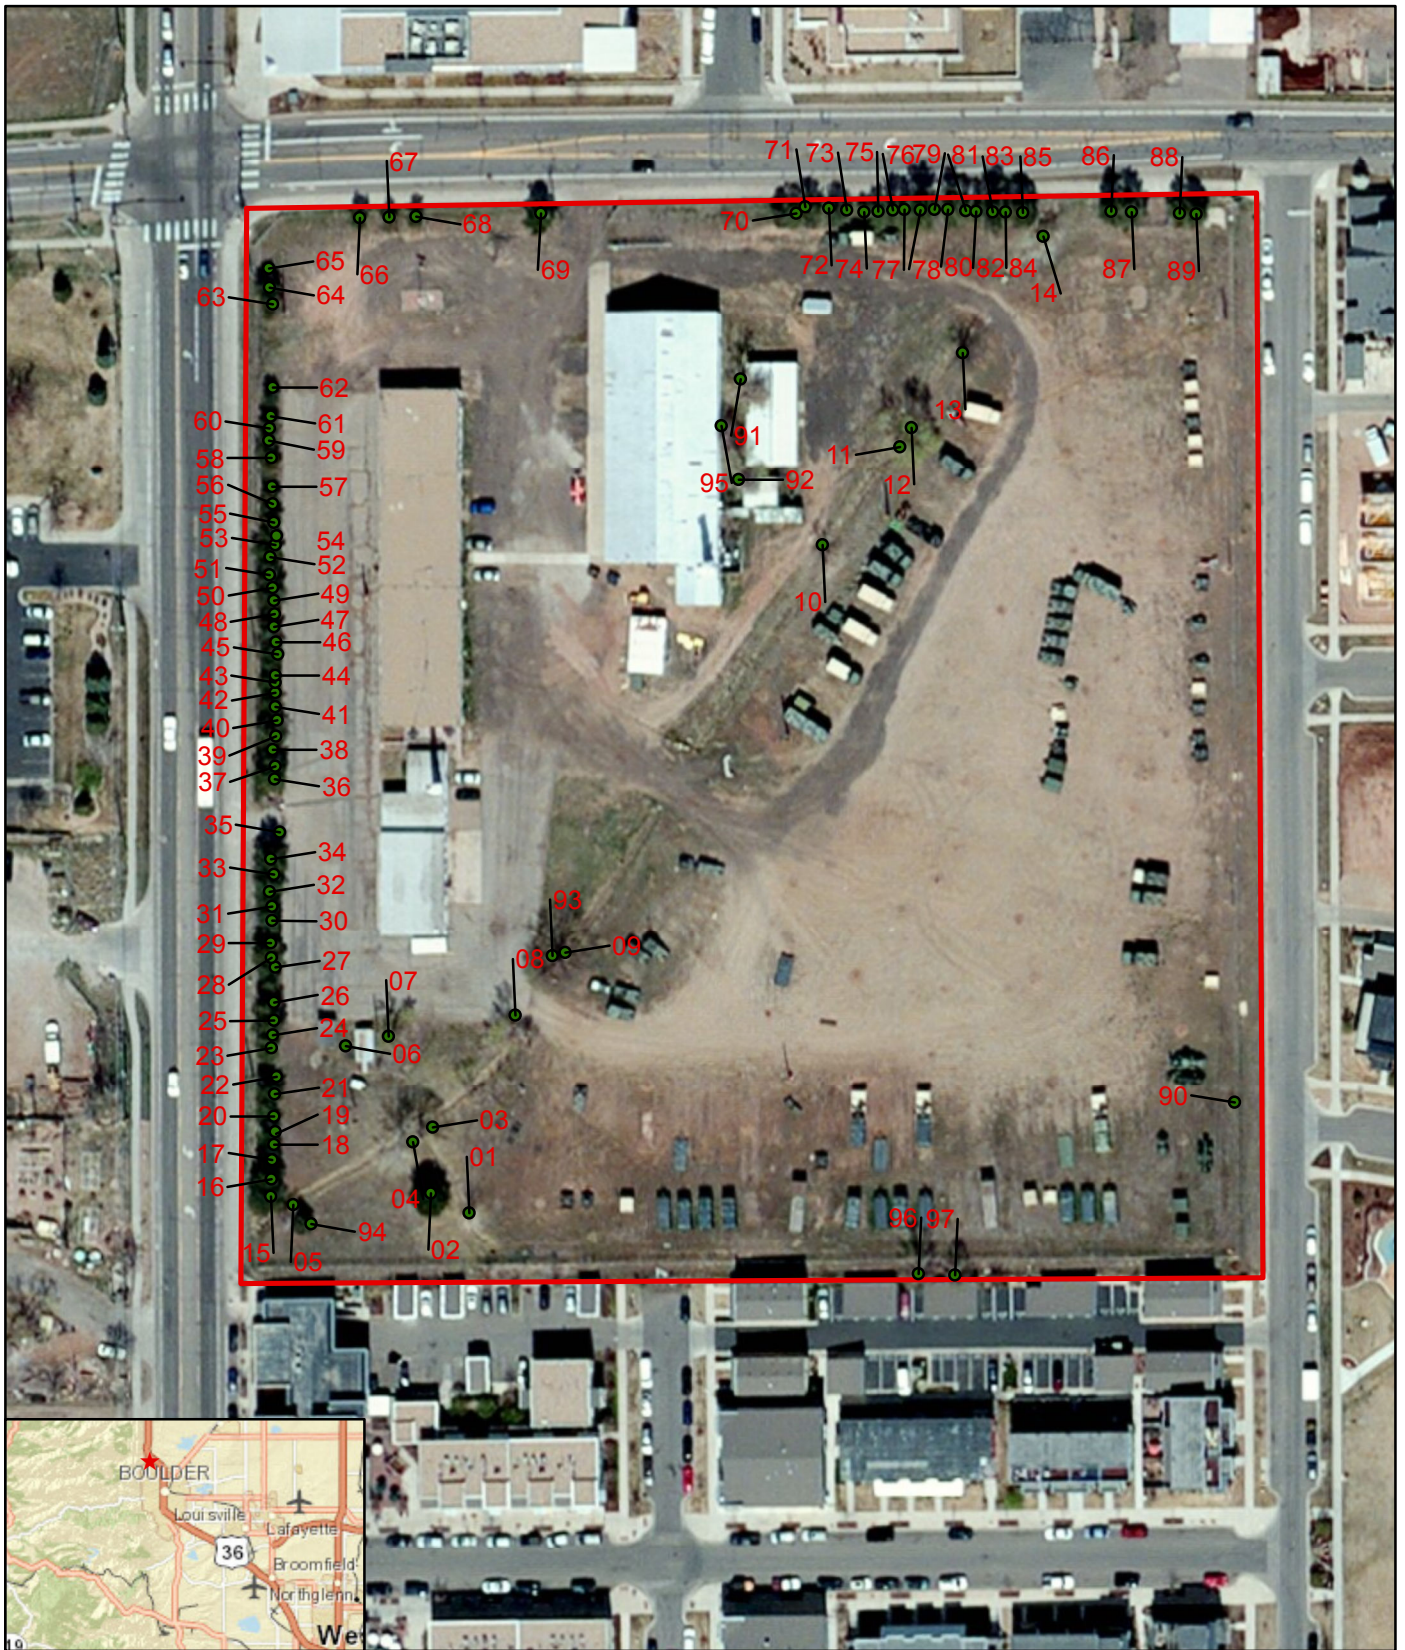
-ID# refers to **Figure 1: ERC Tree Inventory Map 11/5/2014**

Both native and non-native species were identified on the property. Several species of non-native trees are located in the central part of the property and appear to have been planted as part of previous landscaping. There are also a number of deciduous trees which occur along the banks of the Silver Lake Irrigation Ditch and the associated lateral ditch. In addition, there are two trees located within the area bounded by the two parallel chain link fences that occur along the southern Site boundary. Most trees on the property show signs of regular maintenance and were categorized as either excellent or good. The majority of trees identified were ponderosa pines that have been planted along the western and northern property boundaries. Three of the ponderosa pine trees show signs of significant decay and poor health and should be considered for removal. These trees were categorized as very poor.

70	Ponderosa Pine	<i>Pinus ponderosa</i>	9	Excellent	-Native species -No maintenance required
71	Ponderosa Pine	<i>Pinus ponderosa</i>	9	Excellent	-Native species -No maintenance required
72	Ponderosa Pine	<i>Pinus ponderosa</i>	10.5	Excellent	-Native species -No maintenance required
73	Ponderosa Pine	<i>Pinus ponderosa</i>	10	Excellent	-Native species -No maintenance required
74	Ponderosa Pine	<i>Pinus ponderosa</i>	7	Very Poor	- Native species - Likely dead, recommend removal
75	Ponderosa Pine	<i>Pinus ponderosa</i>	10	Very Poor	- Native species - Likely dead, recommend removal
76	Ponderosa Pine	<i>Pinus ponderosa</i>	10	Fair	-Native species -Some maintenance required -Some dead limbs observed
77	Ponderosa Pine	<i>Pinus ponderosa</i>	10	Excellent	-Native species -No maintenance required
78	Ponderosa Pine	<i>Pinus ponderosa</i>	14.5	Excellent	-Native species -No maintenance required
79	Ponderosa Pine	<i>Pinus ponderosa</i>	9.5	Very Poor	-Native species -Likely dead, recommend removal
